## SERVICE LETTER Ref. No.:

## 0014/2014

*Refers to:* Safety recommendations and information for maintenance organizations, aircraft owners and operators re. Case of aircraft forced landing as a result of the significant damage of the engine M137A. Analogic situations might occur at the engine types M337/M332/M137/M132 of all models.

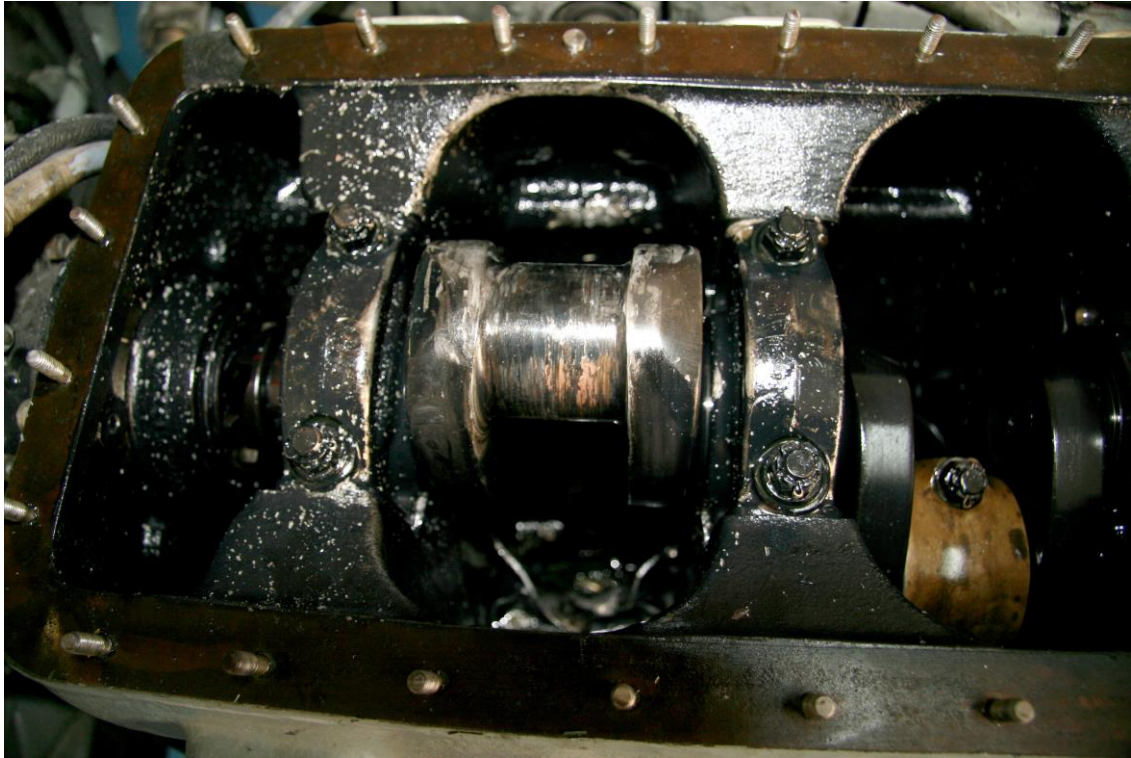
The crank pin No. 6 on the crankshaft and big end bearings were seized – Fig.1

Fig 1 – Crankpin No. 6 – M137A engine

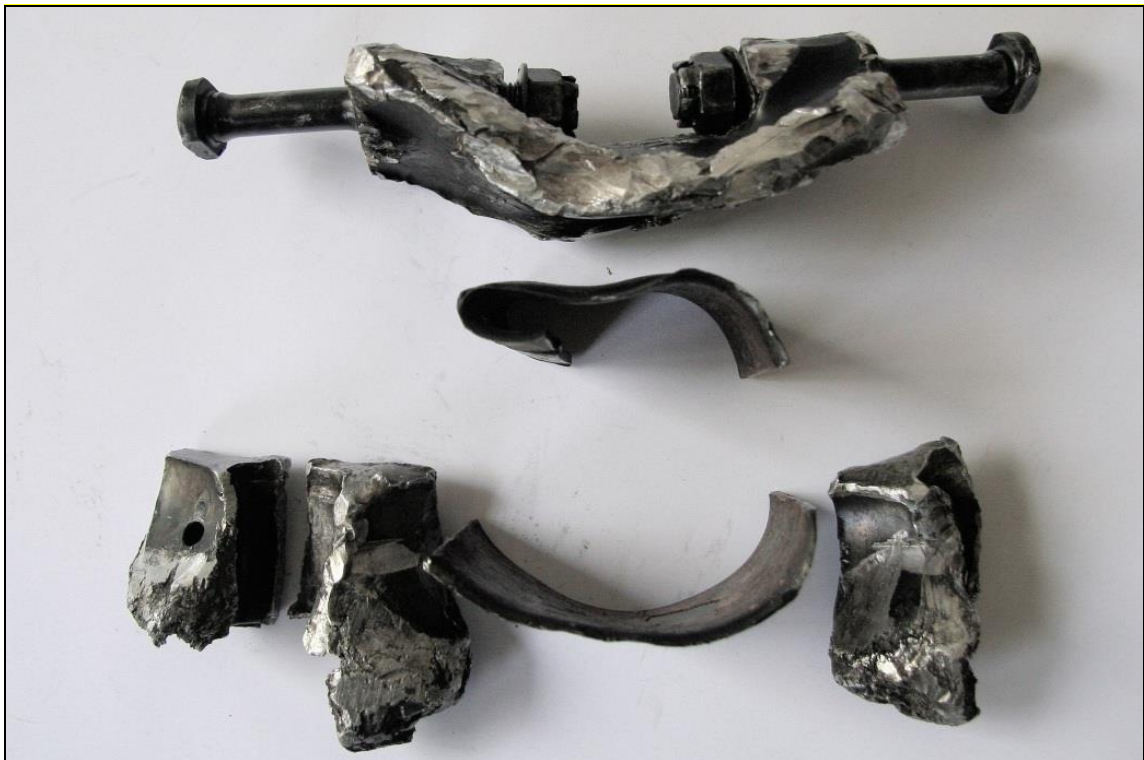
The reduced intensity of the big end bearings lubrication in combination with cotter pins releasing and clearing out from the locking bolts holes on the connecting rod No.6 caused the movability of the big end bearings in the big end hole; the bearings was released from its locked position in the hole. The mutual position big ends upper- and lower halves change caused the additional flexural stress; in combination with increased friction forces intensity between chain connection rod big end- released big end bearings-crank pin came to the static fracture of the connecting rod big end.

Connecting rod No.6 big end is destructed – Fig.2

Fig 2 – Big end upper half No. 6 fragments and deformed big ends bearing.

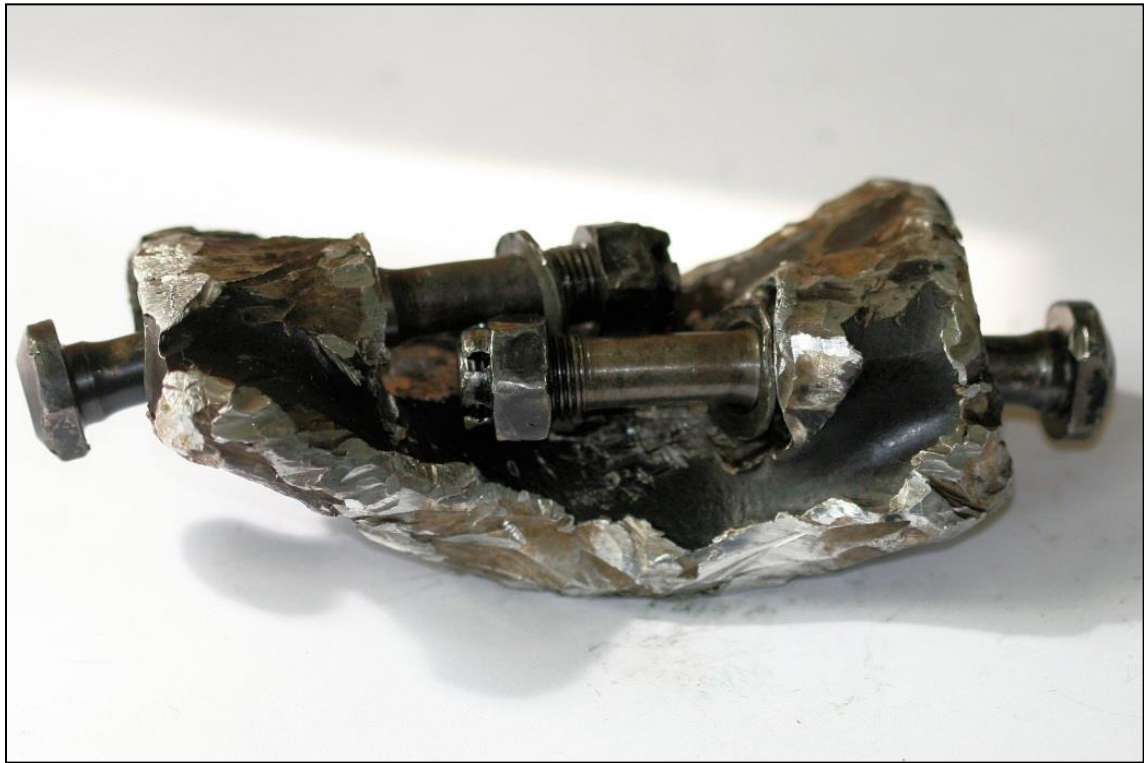
Big end lower half is deformed after impact; Both locking bolts persist in the deformed big end lower half – Fig. 3

Fig 3 – Detail = Deformed big end lower half No.6 and locking bolts w/ female nuts without cotter pins.

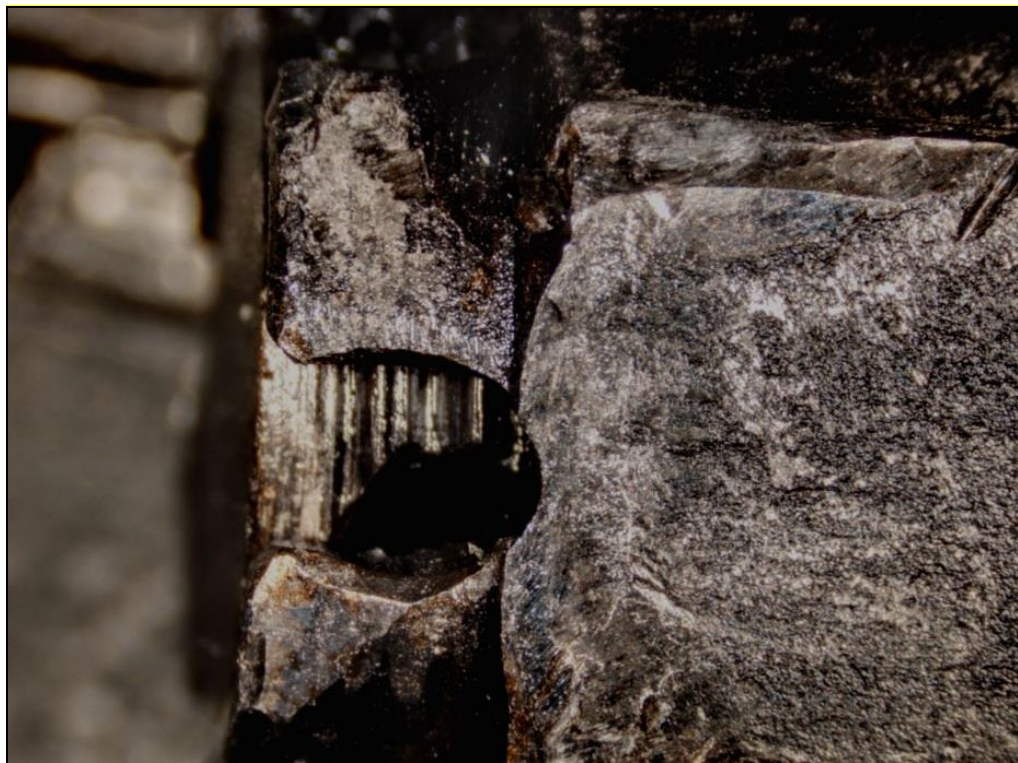
The crown nuts persist on both locking bolts; the cotter pins were cleaned out - Fig.4

Fig 4 – Female nut on the locking bolt on the connecting rod No.6 is turned and not locked by the cotter pin.

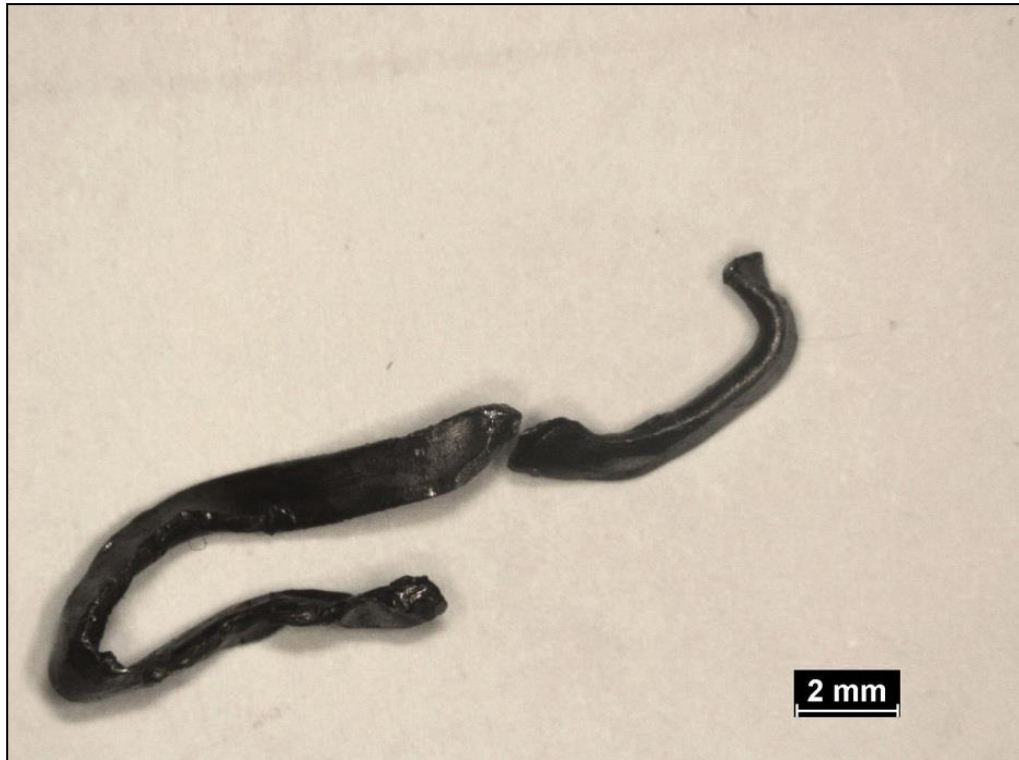
Cotter pins fragments were detected inside of the engine – Fig.5.

Fig 5 – Fragments of the cotter pins belonging to the bolts of the connecting rod No. 6.

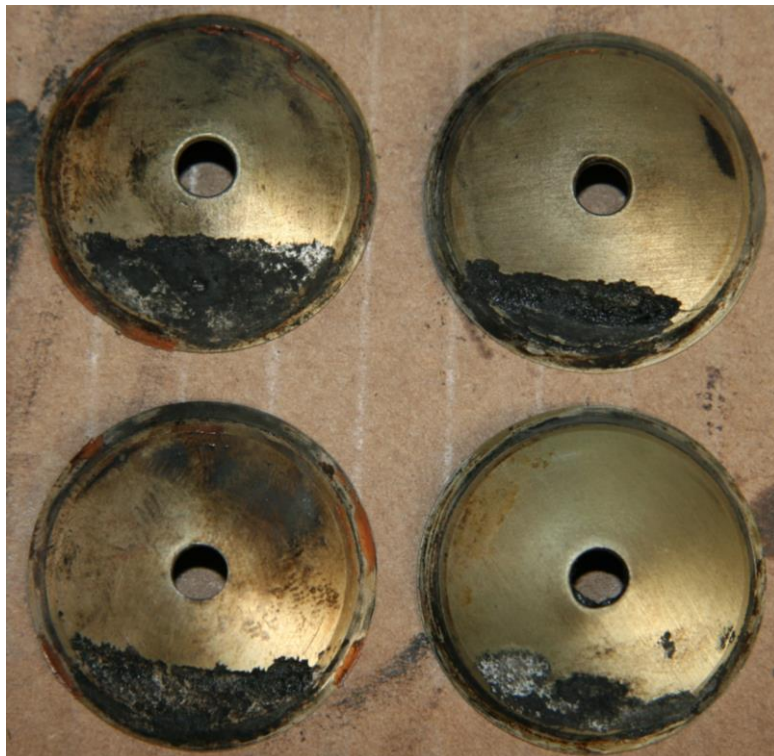
The crankpins hole plugs p/n Sh2036 belonging to the crankpin No.1+6 were affected by heavy corrosion on the internal walls. The corrosion caused the item wall thickness reduction – Fig.6

The area of the corrosion origination is the contact zone of plugs internal surface with the centrifuged oil deposits on the internal surface of the crankpin holes. One crankpin

The crankpins plugs corrosion was caused by the water content in the lubrication oil in combination with negative influence of the components in the non-approved sealing slush (acetate factors).

Fig 6– Corrosion of the crankpins holes plugs, upper part = plugs from crankpin No. 6, lower part = plugs from crankpin No.1 (referential).

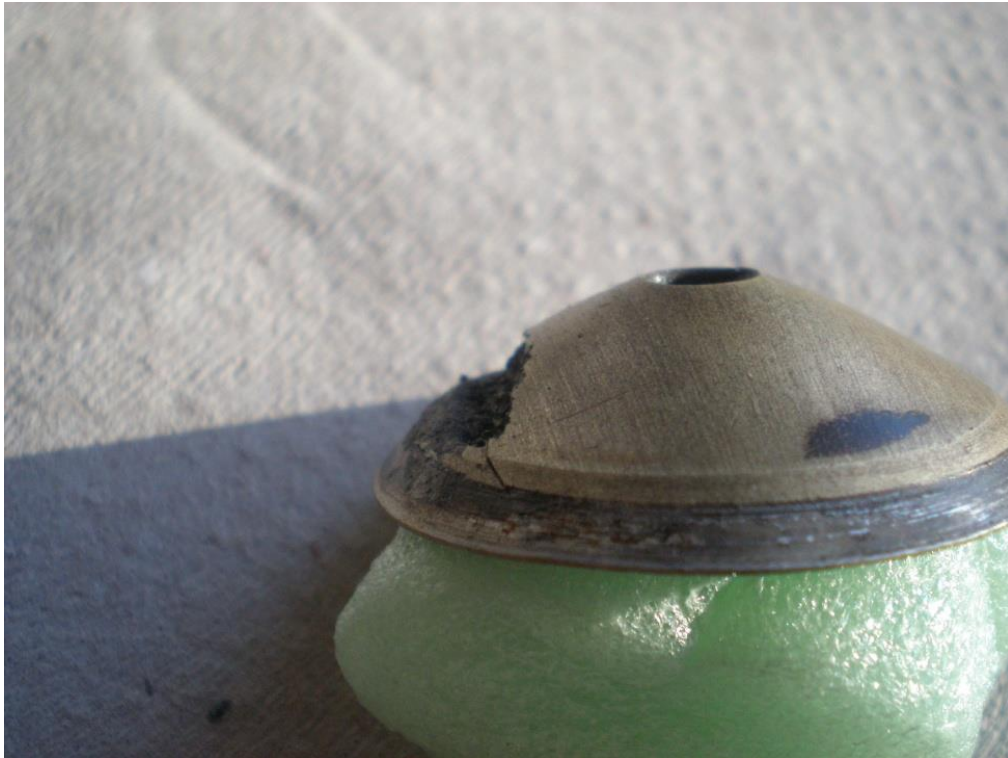
plug belonging to the crankpin No. 6 shows the crack at the area of the item wall thickness reduction – Fig. 7, 8, 9.

The identified crack was the source of the oil leakage from the pressure oil circuit; the intensity of lubrication- and cooling of the big end bearing on the connection rod No.6 was reduced.

Fig 7 – Plug from crankpin No. 6, side view.  
Significant wall wearing by the corrosion affecting.

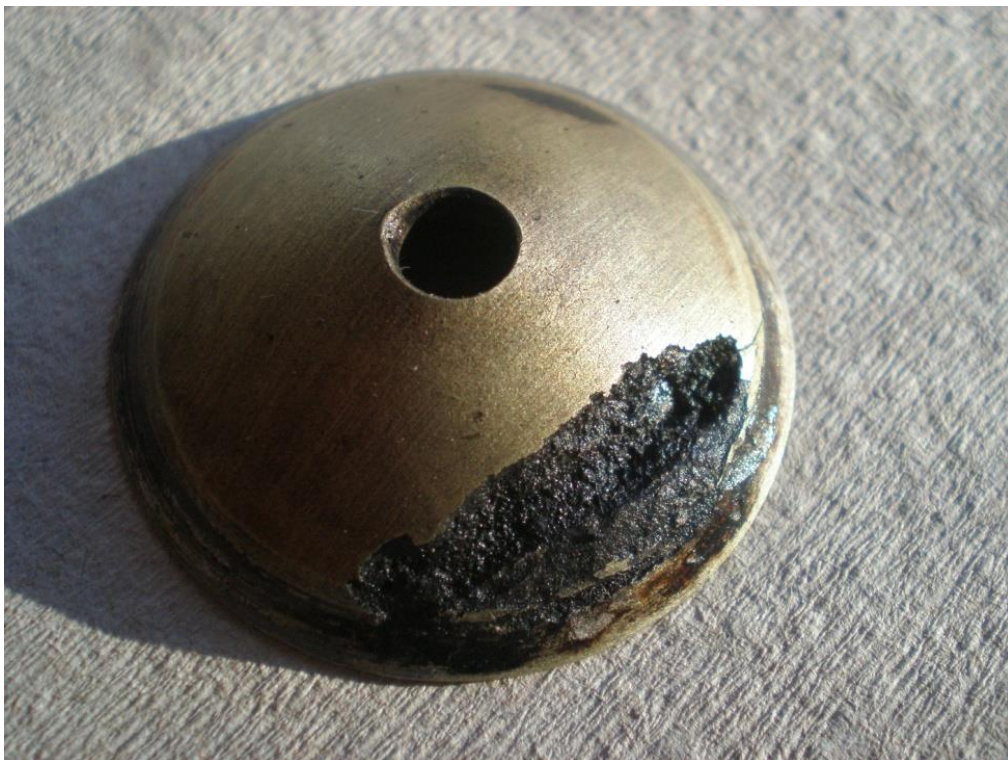
Fig 8 – Plug from crankpin No. 6, bottom view.  
Significant wall wearing by the corrosion affecting.

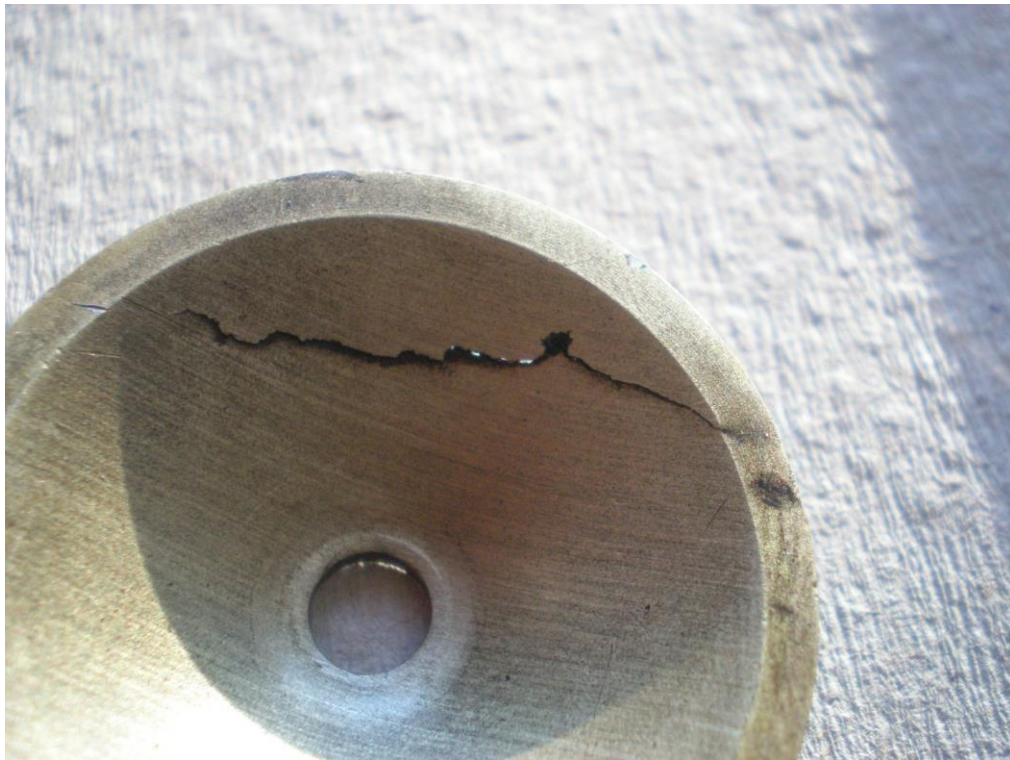
Fig 9 – Crack at the area of the wall wearing on the opposite surface compare to these shown on the Figs 7 and 8 ones.

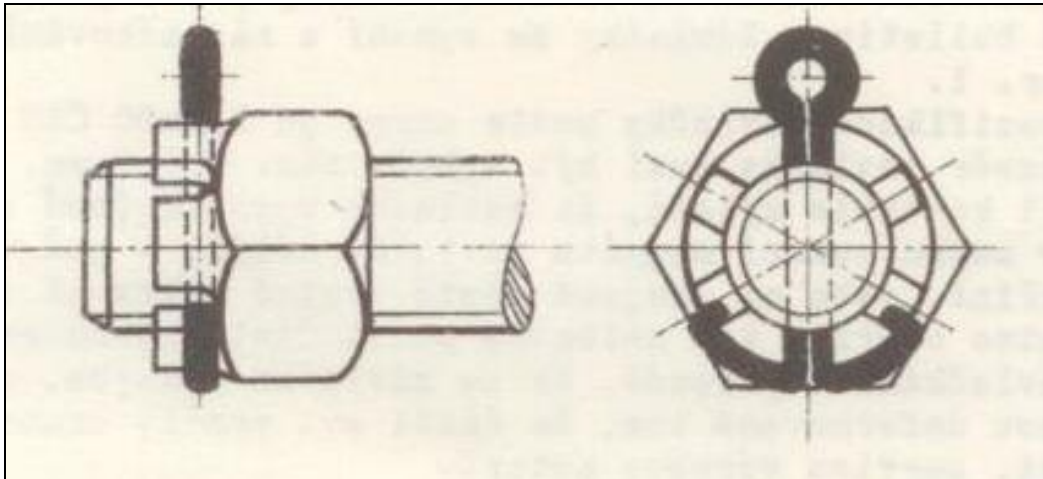
Fig 10 – Sketch shown in Bulleting ref. no M137A/8; the correct way of the cotter pin shaping by the locking of the female nut; the support of the cotter pin in the hole in the locking bolt has to be thigh with aim to eliminate the cotter pin movement or fluttering.

- To follow the provisions defined in the mandatory bulletin reg. no. M137A/8 related to the cotter pins installation. The cotter pin has to be plugged in the locking bolt holes with the minimal clearance; the cotter pins ends shall be shaped as shown on the Fig. 10.
- For the locking of the crown nuts on the locking bolts to use the brand new cotter pins of the proper dimensions only; the cotter pins origin shall be available and parts have to be dully released for the flight service by the appropriate certificate.
- The crankpins plugs have to assure the proper sealing effect by the clean cone seating faces only. The application of sealing slushes of any kind is strictly forbidden.
