SERVICE LETTER Ref. No.:

0015/2016

Refers to: Safety recommendations and information for approved maintenance organisations, owners and pilots concerning the causes of forced landing of an aircraft due to a serious malfunction of the M137A engine. It also applies to engine types M337/M332/M137/M132 of all models.

ANNEX TO SERVICE LETTER Ref. No. 0015/2016

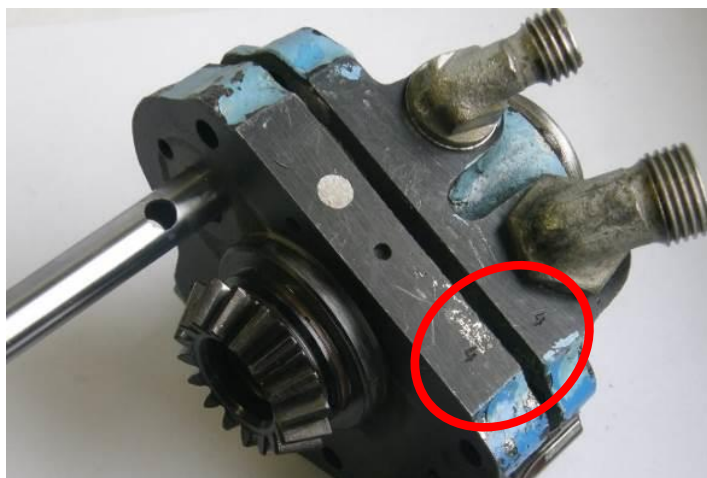
- The replacement of the subassemblies in the scavenge oil pump beyond the manual instructions for maintenance for a pump of unknown origin, at unknown number of working hours.
- The use of worn-down Sc3755 gearwheel of unknown origin, number of working hours and its inversion by 180° so as to engage opposite side of the less worn side of the gear teeth.
- The replacement of the original pump with unit No. 45 for an unknown pump No. 4 has not been recorded into the engine log book.

Fig. 1 – The material damaged scavenge oil pump of the cam housing, set No. 4.

- To entrust the engine maintenance and repairs to authorised personnel in approved organisations.
- The repair of the cam housing of the engine including the built-in scavenge oil pump is not permitted within the scope of the basic maintenance as described in the **OMAE**. To assign the repairs of the cam housing always to approved maintenance organisations authorised to perform engine overhauls on all models and versions of the M132-M337 engines. Within the scope of the maintenance performance in accordance with the OMAE it is permitted only to dismount the complete cam housing – as a whole from the engine and mount it back as a complete set (unit).
- Generally, only the elementary maintenance as described in the **OMAE** is

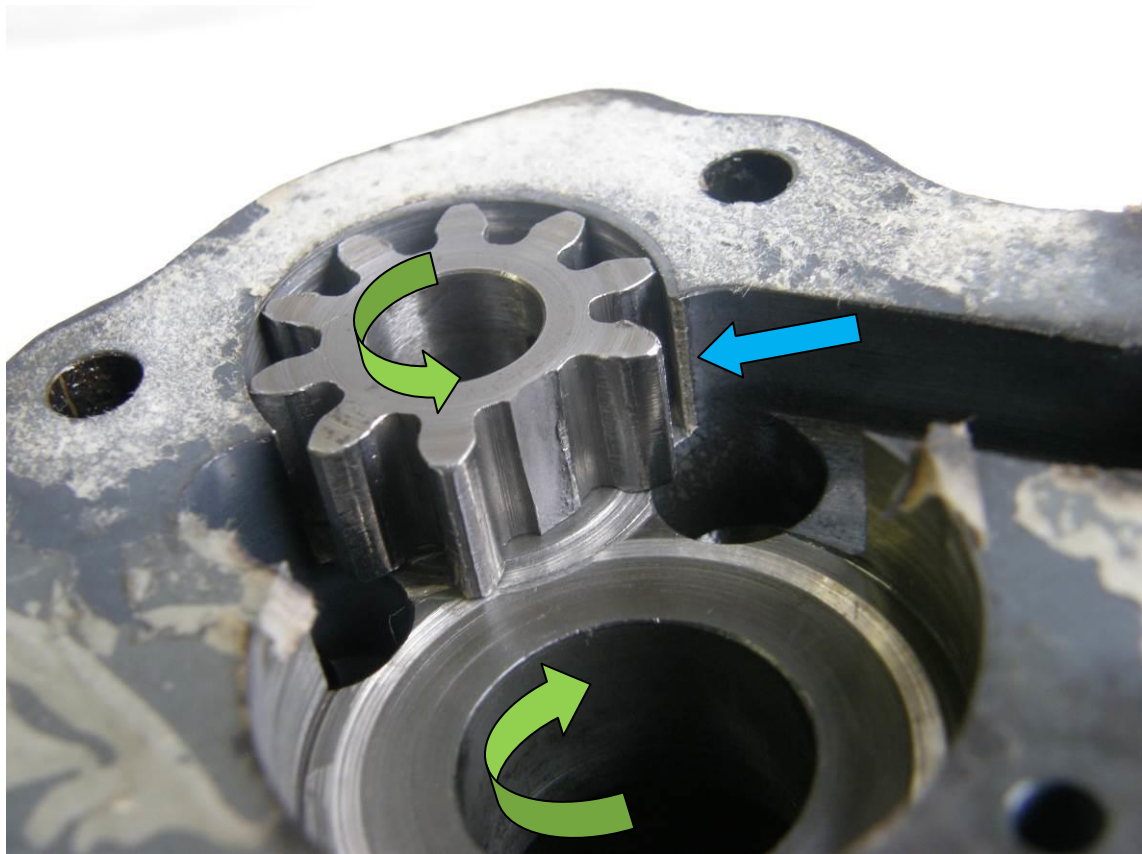
Fig. 2 – The scavenge oil pump of the M137AZ cam housing with worn-down teeth and abraded edge of the chamber, the green arrows indicate the direction of rotation of the gear, the blue arrow points to the edge of the chamber abraded by the gear burrs.

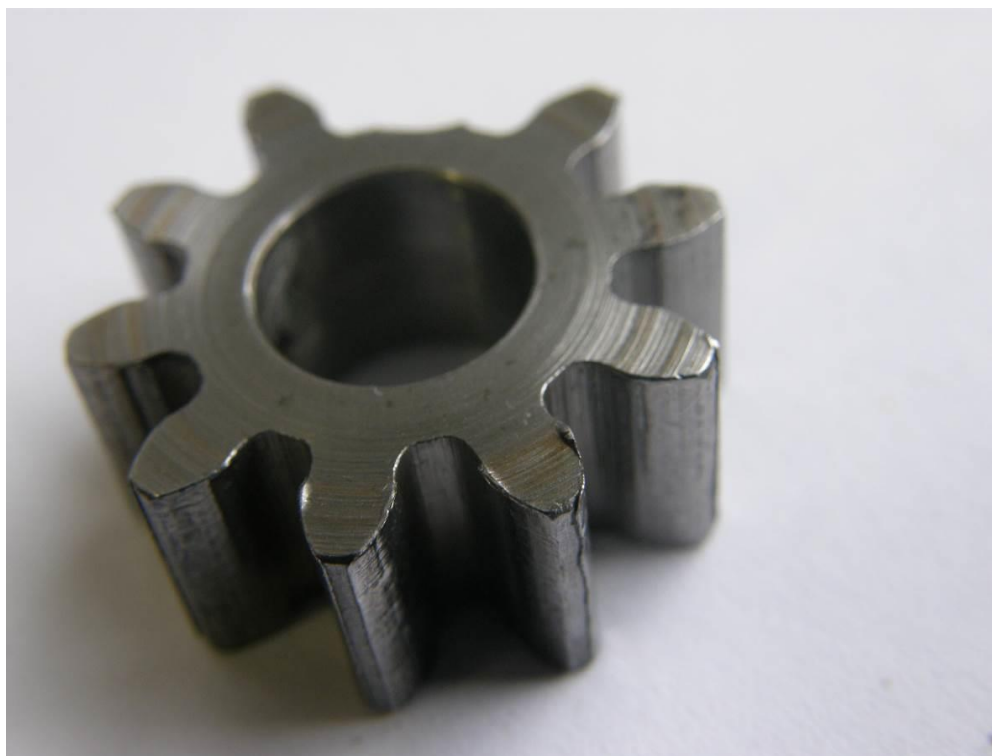
The worn-down worm wheel with burrs on its sides as well as around the circumference had incorrect radial, axial and tooth clearance. During the engine operation further wear was taking place on the opposite side of the gear teeth, cyclic stress on the teeth in bending direction due to impact caused by hitting into the edge of the chamber and scuffing of the driven wheel. These factors caused the fatigue fracture of teeth, and block rotation of gear set of the pump. The damaged gear set of the pump suddenly made it impossible for the vertical shaft to turn and the central bevel gear broke the teeth on the vertical shaft. The transmission of the torque onto the injecting pump and camshaft was interrupted and the engine cut off suddenly.

Fig. 3 – The p/n Sc3755 wheel with the burrs on both edges and the teeth circumference.

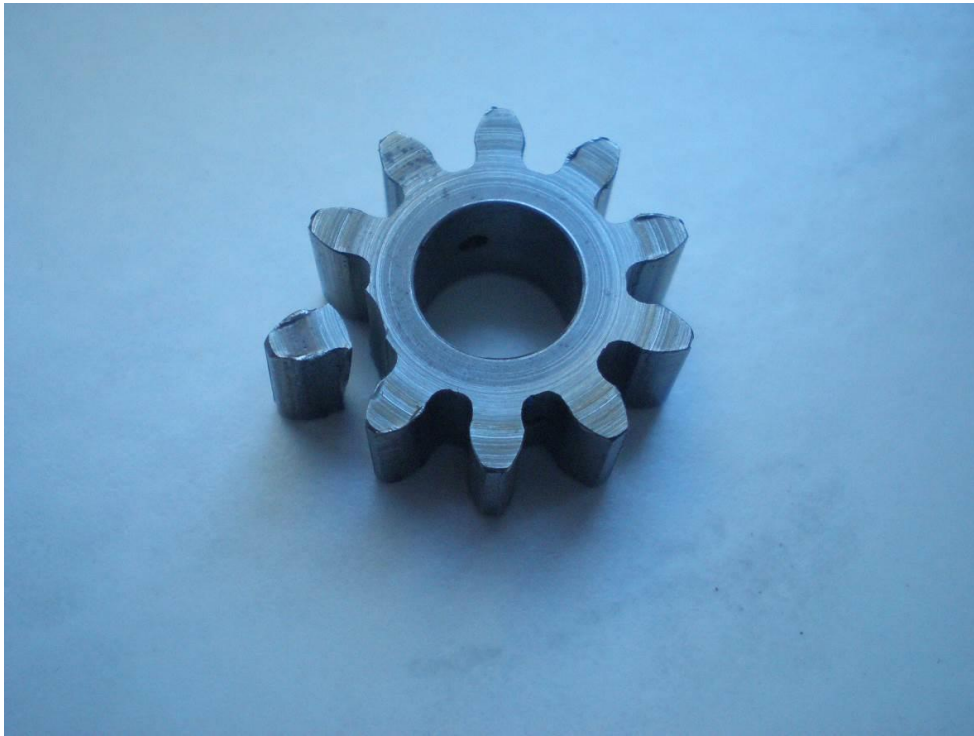
Fig. 4 – The damaged p/n Sc3755 gearwheel with a broken off tooth.

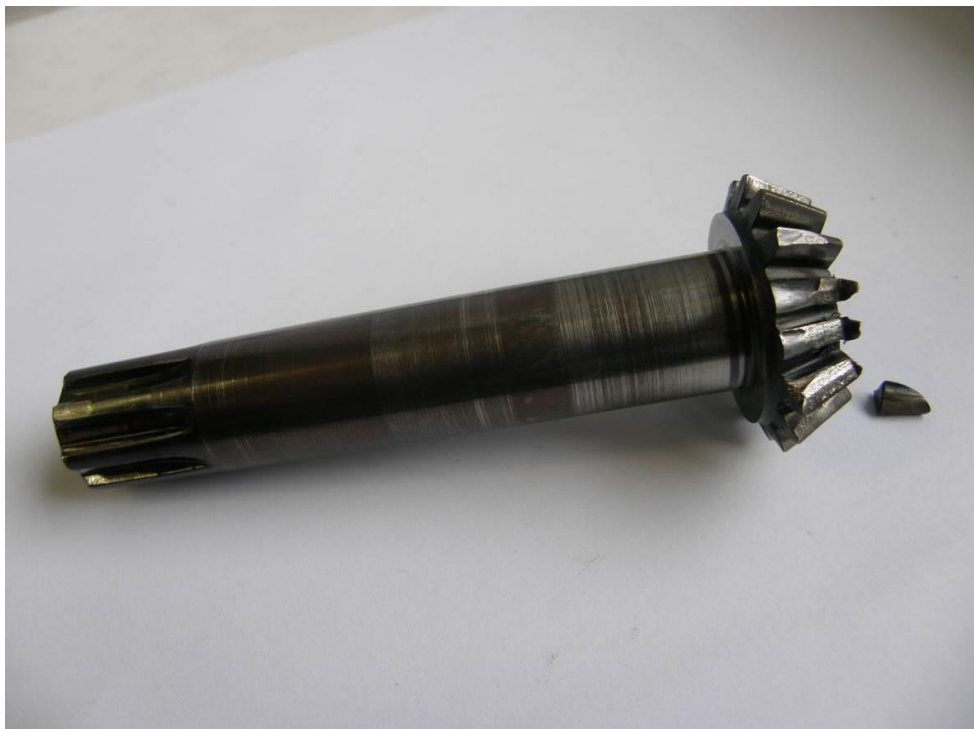
Fig. 5 – The damaged cog wheel of the vertical shaft, consequence of the blocking of the pump.

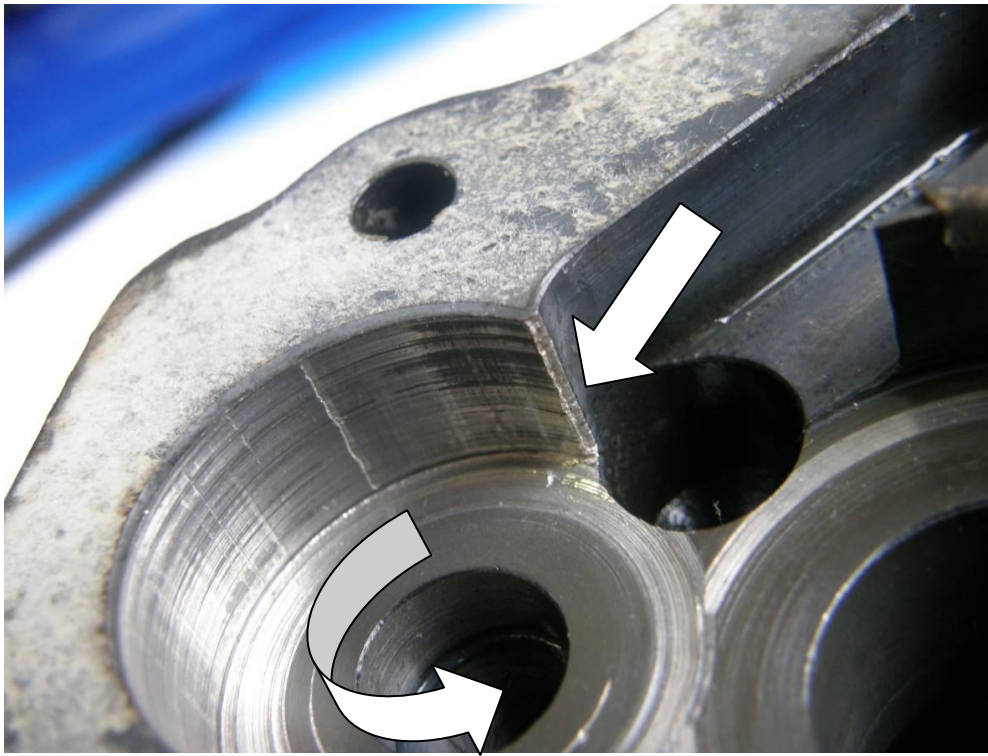
Fig. 6 – Detail of the pump housing, abraded edge and worn-down base of the housing.

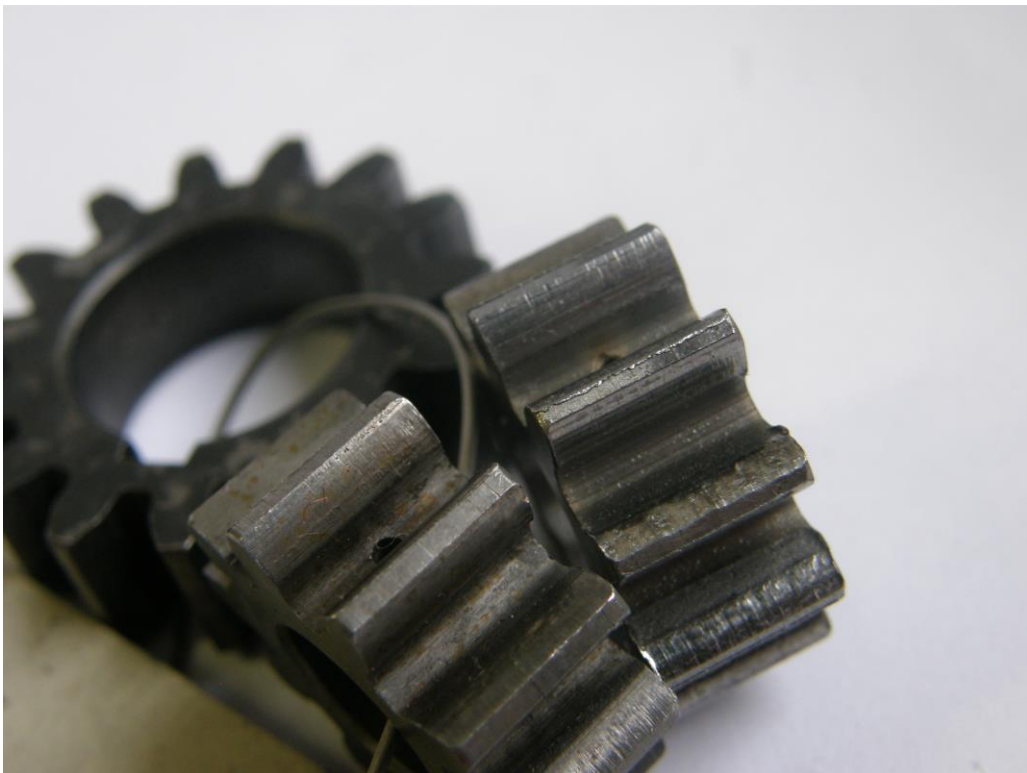
Fig. 7 – Comparison of the gearwheel after 1,400 hours of operation (left) and the damaged gearwheel of unknown origin (right).
