## SERVICE BULLETIN

M 137 A/8

**CONCERNS:** Split-pin-locking of connecting rod bolt castellated nuts of the new M 137 A, M 137 AZ, M 337 and M 337 A aeroengines as follow here below:

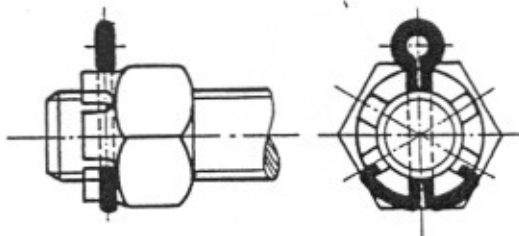
**CAUSE :** During the air service of several aeroengines stated above has been found some spontaneously loosened or hurted or even lost locking split pins of connecting rod bolt nuts.

3. Unscrew successively the 44 pcs. of nuts M6 and 2 pcs. of nuts M 8 from the engine crankcase top cover, Part No. Sh 0131, then remove the crankcase top cover carefully so that not to damage the cover gasket, Part No. Sh 1305.
4. Then turn through slowly the engine crankshaft and examine successively the connecting rod nut locking split pins if they are faultless, unbroken.
5. Now remove carefully and successively the split pins so that no of the split pins nor any fragments of them drop down into the engine crankcase.
6. Then replace successively the split pins by new ones conformably to the following Fig. 1:

**Caution:** The new locking split pins have to be of minimum dia. 1,9mm. The split-pin-locking of the castellated nuts referred to has to be carried out carefully, the split pin eye must not be deformed by hammer strokes and the split pin after having locked must not be loose in the castellated nut. If the split pin length is not adequate to the required length as illustrated in Fig. 1 it has to be adapted conformably to the sketch.
