## LOM PRAHA

No.: M 137 A/15a

SERVICE BULLETIN

Application of cylinder head Sc 2706 marked "Z" together with special plain washers - cylinder head stud bolt nut Sc1504R for all types and versions of engines stated above.

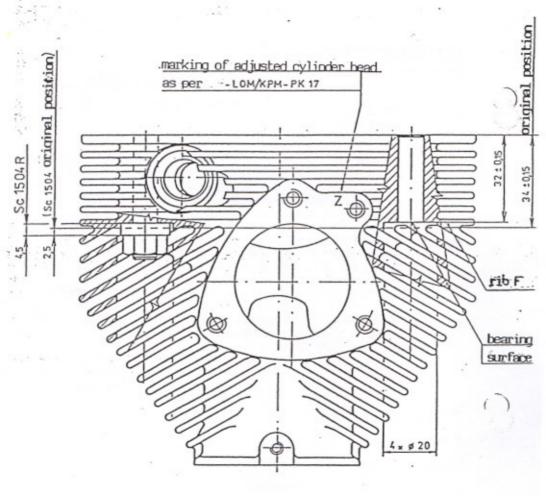
In consequence to change of casting there is adjusted recessing of 4: clamping holes Ø 20 mm on cylinder head Production No. Sc2706 marked : "Z" from 34 ± 0,15 mm to 32 ± 0,15 mm (see enclosed pict.) and there are strenghtened plain washers-cylinder head stud bolt nut from: 2,5 mm. (Production No. Sc 1504) to 4,5 mm (Production No. Sc1504R).

If it will be necessary to replace cylinder head in service or repair used cylinder head marked "Z" (marking is situated on cylinder head intake flange), it is necessary to use special plain washer-cylinder head stud bolt nut Production No. Sc1504R. It is necessary to note this fact into the Engine Book, to the parts "Engine Run Diary" and "Special Notes" note of reading as follows: "Cylinder heads marked "Z" and special plain washers Production No. Sc 1504R were mounted on engine" (coressponding No. of Bulletin is to be stated). Next there will be note Production No. and Position No. of the engine cylinder head.
